# Smart Patch for monitoring the integrity of steel frame joints

H. Chung<sup>\*a</sup>, S. Beard<sup>a</sup>, C. Zhang<sup>a</sup>, C. Aquino<sup>a</sup>, J. Mapar<sup>b</sup>

<sup>a</sup> Acellent Technologies, Inc., 835 Stewart Drive, Sunnyvale, CA, USA 94085;

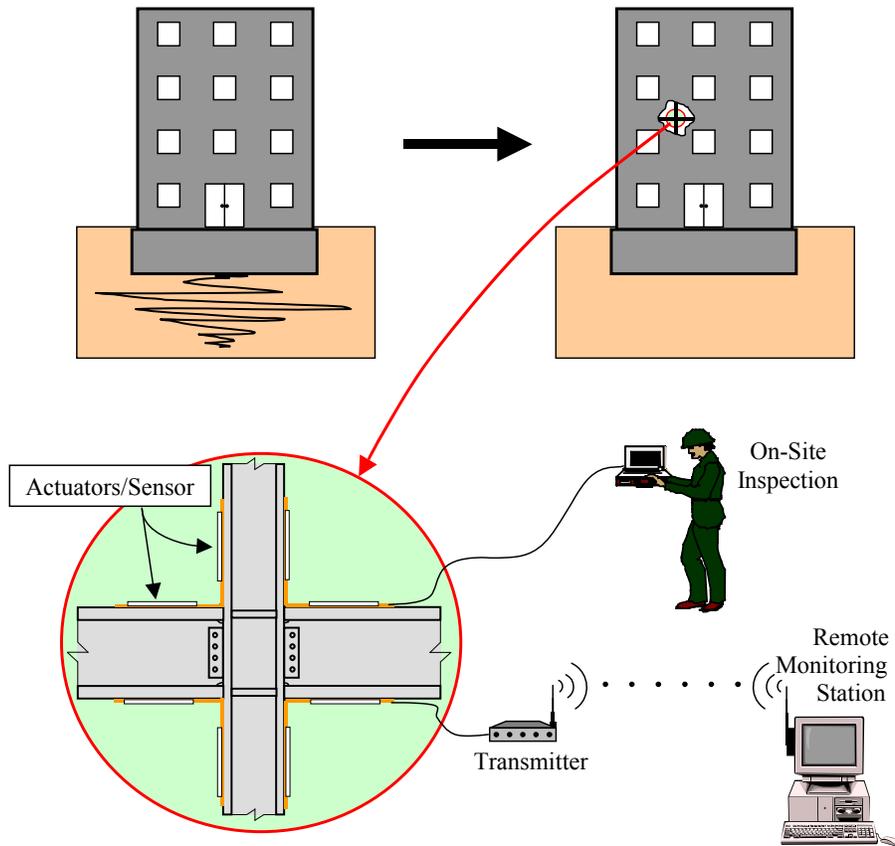
Fig. 2 Smart Patch Joint Monitoring System Development Model

The SMART technology offers a solution to the current problems associated with inspecting welded beam-to-column moment connections in WSMF structures. By applying techniques that utilize Acellent's SMART Layer<sup>®</sup> concept, sensors located on and around the beam-to-column connection can autonomously assess the integrity and long-term durability of the joint (Fig. 2).

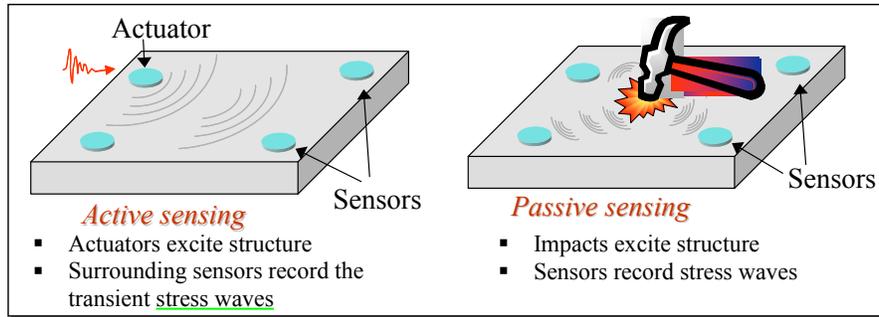
Fig. 3 Active and passive sensing methods

The SMART Layer technology is currently available for both *active* and *passive* sensing capabilities using piezoelectric sensors (PZT). In Active Sensing Mode, each piezoelectric element can be used as an actuator to excite the structure while the neighboring sensors listen. The sensor responses can then be interpreted in terms of damage location and size or material property changes within the structure. In Passive Sensing Mode the SMART Layer can be used as a continuously monitoring sensor network to “listen” for impact events. Both Modes permit real-time structural analysis and evaluation along with constant collection of structural data and information while the structure/vehicle is in service. Figure 3 shows the working concept of active and passive sensing.

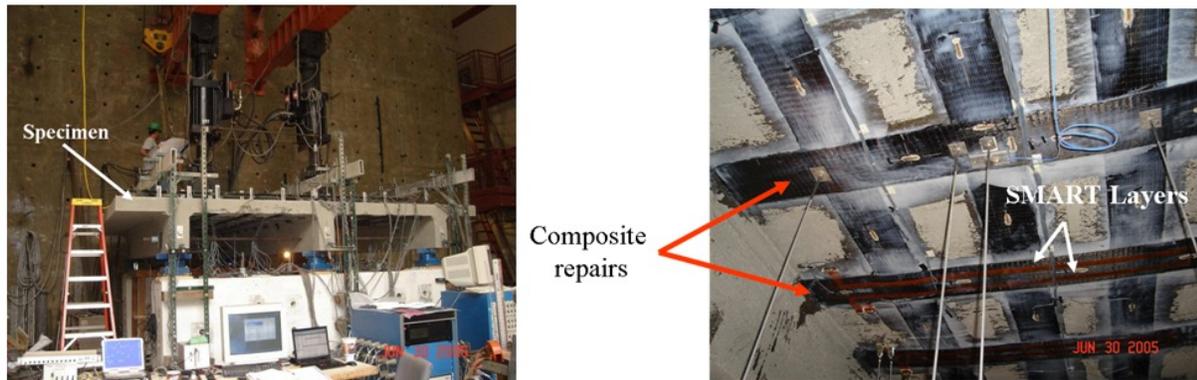
Fig. 4 Acellent's SHM systems used for evaluating composite bridge repairs

*B) Monitoring of bridges and off-shore structures:* While more than 40 percent of the over 500,000 bridges nationwide are either structurally deficient or functionally obsolete mainly because of aging, rehabilitation of these bridges becomes the only feasible solution. Among a variety of rehabilitation technologies available, externally bonded Carbon Fiber Reinforced Plastic (CFRP) composite strips have been demonstrated to be one of most promising method for repairing and/or reinforcing damaged structures in a large scale to prolong their service lives and avoid loss of lives and assets. Recently, Acellent's Structural Health Monitoring (SHM) systems have been used as nondestructive evaluation tools for detecting the disbonds between composite repair patches and deck slabs of concrete in bridge rehabilitation (Fig. 4) [15]. In addition to monitoring of bridge repairs, damage prone areas on bridges and off-shore structures such as oil-rigs are also potential applications that can utilize the Smart Patch system.

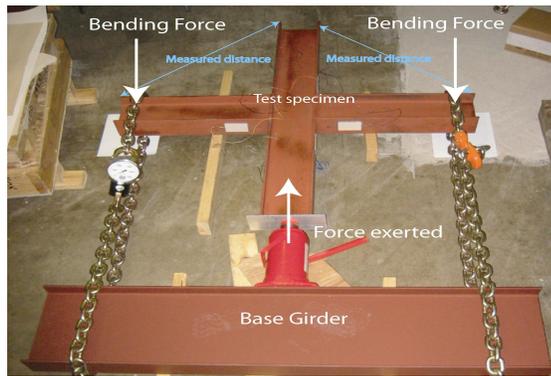
Fig. 5 Welded Steel Moment Frame Specimen and Testing Method

Piezoelectric transducers of size 2"x3" with a thickness of 0.1" were obtained from appropriate vendors. These were mounted on the steel test specimen as shown in the figure below. Eight transducers were mounted for preliminary testing, two on each leg. A set of baseline signals was taken with the sensors using existing data acquisition hardware.

A test-setup was designed to deform the test article instrumented with the sensors. A picture of the test set-up is shown below. The goal was to determine the rigidity of the specimen. To do this the specimen needed to be bent under stress. In order to ensure a change in rigidity, cuts were made in the test specimen at the joints. Bending was accomplished by using chains around the test specimen and a base girder. Force was applied using a 30 ton jack and measured using the force gage (Fig. 6). The distance between the edges of the test specimens was measured at set force levels.

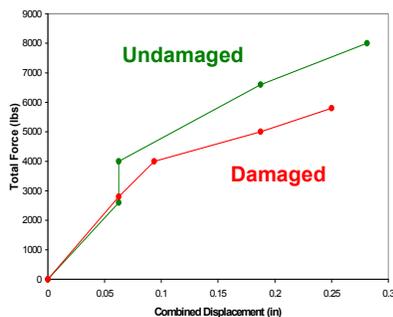
Fig. 6 Displacement in the undamaged and damaged state

As stated above, a measure of the joint rigidity was obtained by applying a load to the specimen and measuring the induced displacement,  $d$ , between the corners of the frame. This was done before and after adding damage (cuts at the joint) to the specimen. Figure 6 shows the load-displacement curves for the undamaged and damaged frame. The chart clearly shows a loss in joint stiffness after being damaged.

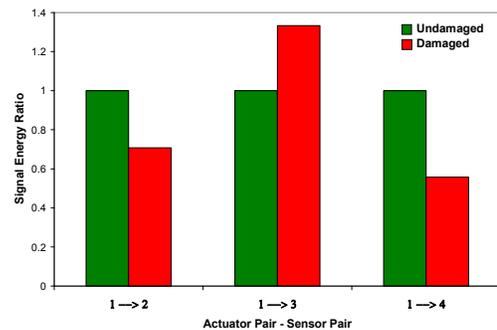
Fig. 7 Signal energy ratio for signal paths

Figure 7 shows the signal energy ratio computed from the experiment of bending moment tests. Sensor data was also collected before and after inducing damage in the structure. On one leg, two piezoelectric actuators, with opposite polarity, were excited by a 4 kHz sine wave pulse. The transmitted signal energy for actuating and sensing transducer pairs 1 → 2, 1 → 3 and 1 → 4 was calculated for the damaged state. These values were normalized against the transmitted

signal energy from the undamaged state. As can be seen, the signal energy ratios for actuator and sensor pairs 1 → 2 and 1 → 4 are reduced (below 1.0), while the signal energy ratio for actuator and sensor pair 1 → 3 is increased (above 1.0). This is due to the fact that as damage accumulates, and the stiffness of the joint is reduced, less energy can be transmitted from the column to the beam, resulting in lower signal energy ratios for actuator and sensor pairs 1 → 2 and 1 → 4. Also, since less energy is transmitted to the beam, more energy stays in the column, resulting in a higher signal energy ratio for actuator and sensor pair 1 → 3.

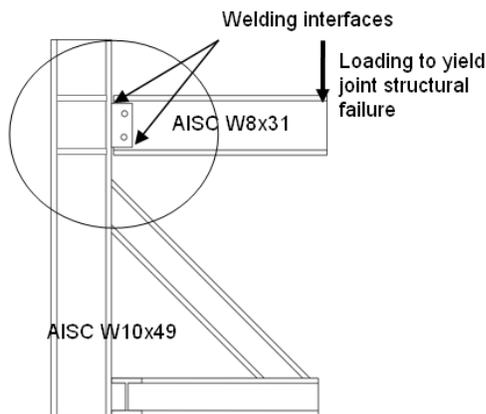
Fig. 8 Beam-column Joint Specimen

Accellent worked with Leighton Group Engineering Corp. and Testing Engineers, Inc. to fabricate an external beam-column joint specimen for testing of Smart Patch system. The beam member is following American Institute of Steel Construction (AISC) W-8x31 wide beam specification, and the column is W-10x49. The joint interfaces between beam and column were completely penetration grooved welds and the work was done by certified welders. The design of specimen is shown in Fig. 8.

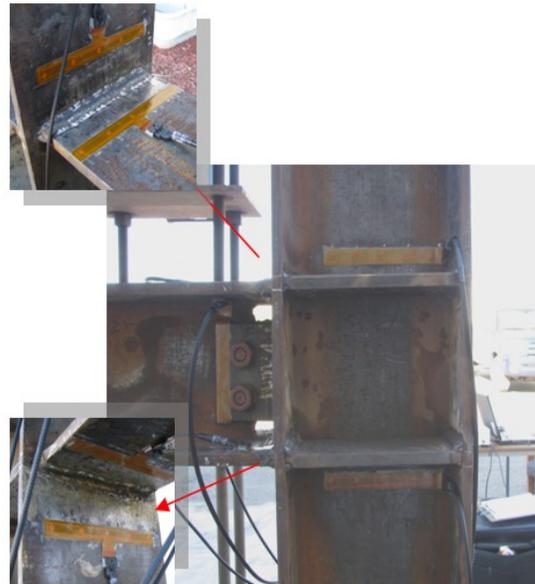
Fig. 9 Smart Patch Sensor Installation for External Beam-column Joint Component

Figure 9 shows the types of SMART Layers for sensors and configuration. Circular piezoelectric transducer and sensor with a diameter of 1/4" and a thickness of 0.1" was selected to be embedded in SMART Layers for external beam-column joint specimen based on its optimal signal performance in the earlier coupon testing. Two types of

Layers were used: Type 1, T-shaped with 5 PZT disks and, Type 2, a stripe with 4 PZT disks embedded. Two pairs of Type 1 SMART Layers were mounted for monitoring the welded interfaces between beam and column. One pair of Type 2 SMART Layers were installed in between the column and the shear resisting bolted plate in the middle of the beam section. The last pair of Type 2 SMART layers were mounted for detection of damage near the beam web and column's interface. Another pair of Type 2 were mounted on the column web surface for monitoring the rotation of column near joint center. The baseline signals were taken using ScanGenie™ system [17].

<ul style="list-style-type: none"> <li>T-shaped (2"Hx8"L) Layer</li> <li>Connector in the middle</li> <li>5 PZT Sensors, 1/4 in Diameter Circular Disk</li> <li>Spacing 1.75"</li> <li>Installed on the Flange Surface of I-Beam</li> <li>Monitoring the welded interface between the beam and column connection</li> </ul>
Type II

<ul style="list-style-type: none"> <li>Stripe Layer (8"L)</li> <li>Connector in the end of stripe</li> <li>4 PZT Sensors, 1/4 in Diameter Circular Disk</li> <li>Spacing 1.5"</li> <li>Installed on the surface of Web of I-Beam</li> <li>Used for               <ol style="list-style-type: none"> <li>Monitoring the welded interface between the beam web and the flange of I-beamed column</li> <li>Monitoring the deflection (plastic hinge behavior) of the web section of column</li> </ol> </li> </ul>

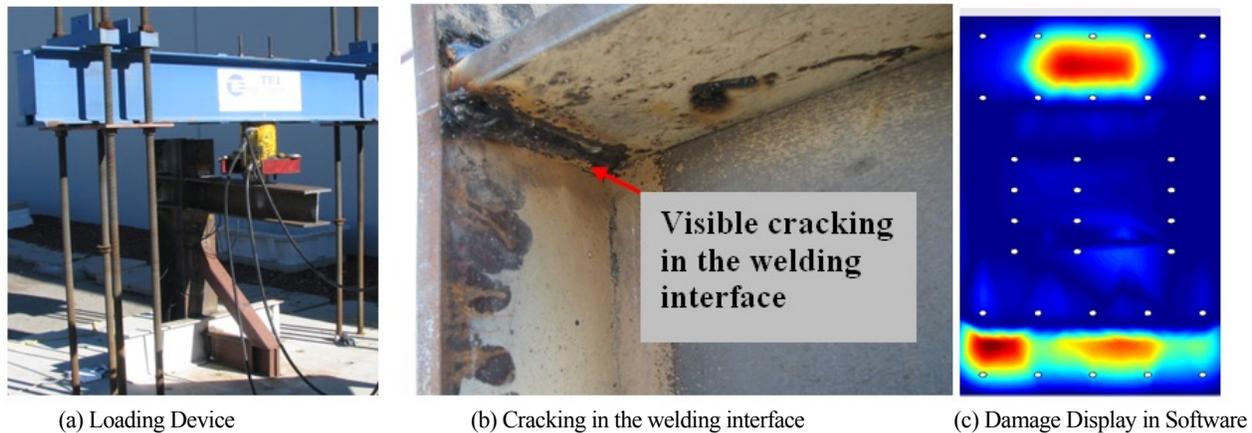
Fig. 10 External Beam-Column Joint Component Testing and Damage Image Display from Acellent ACCESS software

The specimen testing was performed in the certified test center, Testing Engineers, Inc., in San Leandro, CA. During the testing, we applied the loading to the beam element to cause the maximum bending moment in the beam-column joint. The loading for the test was applied with an initial loading of 20 kips incremented by 10 kips at each interval (Fig. 10(a)). The structure eventually failed by the loading to 114 kips, right after the loading of 110 kips. The data were taken at the loading of 20, 30, 40, 50, 60, 70, 80, 90, 100, 110, and 114 kips. At this load, we checked the structure and found a crack in the interface of stiffener and the flange of the column section as shown in Fig. 10(b).

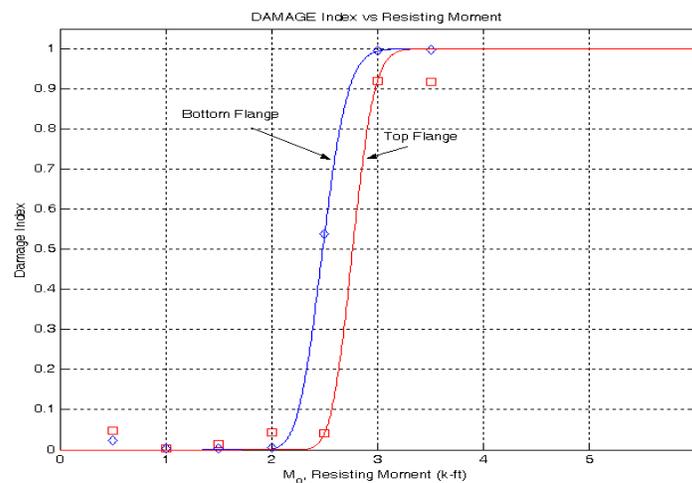
Fig. 11 Quantitative Diagnostics Result from Smart Patch ACCESS software

Acellent Software Suite (ACCESS) is the standard software developed in the Smart Package of Acellent's active structural health monitoring system [17-18]. This is system can perform a data management platform for piezoelectric acoustic ultrasound sensors. With the design of signal processing modules and damage detection algorithm, we can quantify the damage degrees in terms of damage index. Fig. 11 shows the results using Total Signal Energy (TSE) of scatter signal in the first-mode arrival time window (FAW) as known as time window analysis.
